## **Penzance Harbour South Pier & Lighthouse Pier History and Condition (Stage 1)**

Cornwall Council

22 March 2013

FINAL REPORT

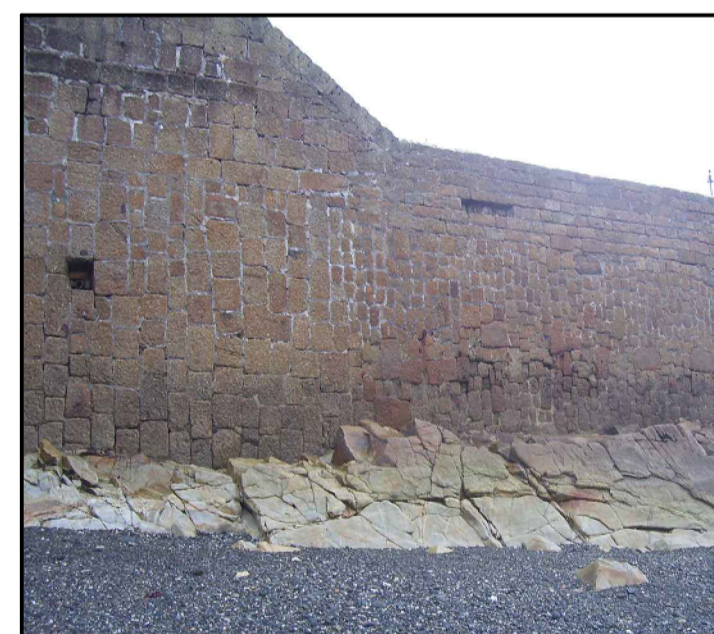
Photo 6 on Figure 2 illustrates the section of the south pier where the natural rock outcrop at the foot of the structure meets the pebble beach. There are two areas that show signs of further movement since 2004 and these areas are considered to be in need of repair work. Within this section there appears to be areas of mortar missing at the lower part of the wall

(Photo 9) and in the upper part of the wall there appears to be a line of masonry blocks missing (Photo 10). Masonry within the two areas highlighted appears to have moved since 2004, being pushed back further within the structure. This would suggest some voiding. The harbourmaster believes that there is a void within the pier extending from surface level to below mean sea level. There is no evidence that repairs have been carried out to address this deterioration and further investigation is required of possible voids. Repair work is considered to be a high priority within a planned maintenance programme. Repairs would need to be undertaken irrespective of any other options associated with managing the use or overtopping of the Pier..

Photo 6 - South Pier Protected by Rock Outcrop  
2013 RHDHV Inspection

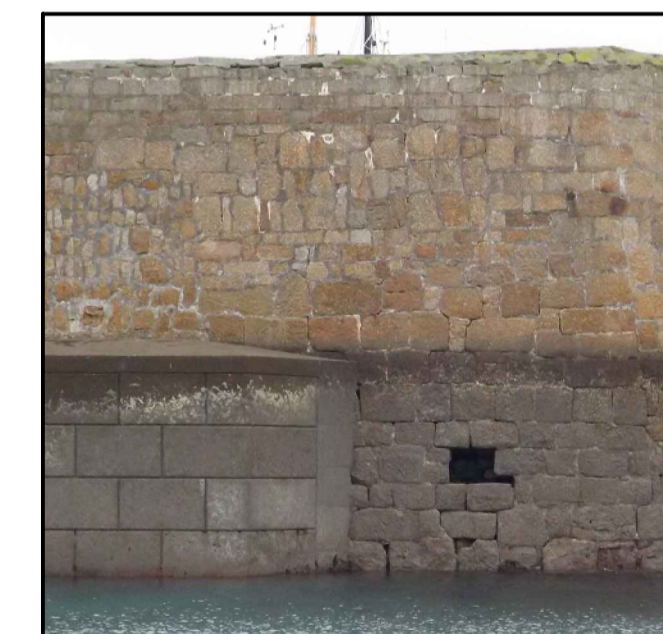
A large block was missing from the pier wall to the north of the concrete toe (see photos 8 and 14). During the 2004 inspection this section of wall was still intact. However, an area of missing mortar could be seen directly beneath the missing block. It appears that the wall is backed by relatively large stones (reportedly part of an old quay wall). Some of this fill behind has been displaced but it appears that it is relatively stable. It is likely that waves breaking within the voids between blockwork have caused large pressures between the outer face and the relatively solid inner face and that this has pushed the block out from within. This mechanism was put forward as a key concern, in the Paul Carpenter Associates' report in January 2010, as an argument against internal grouting of the structure. (The defect was raised during the discussion during the site visit and it is understood that the immediate action is to be taken to repair this section of the wall).

Photo 8 - South Pier Right of Concrete Build-out  
2013 RHDHV Inspection

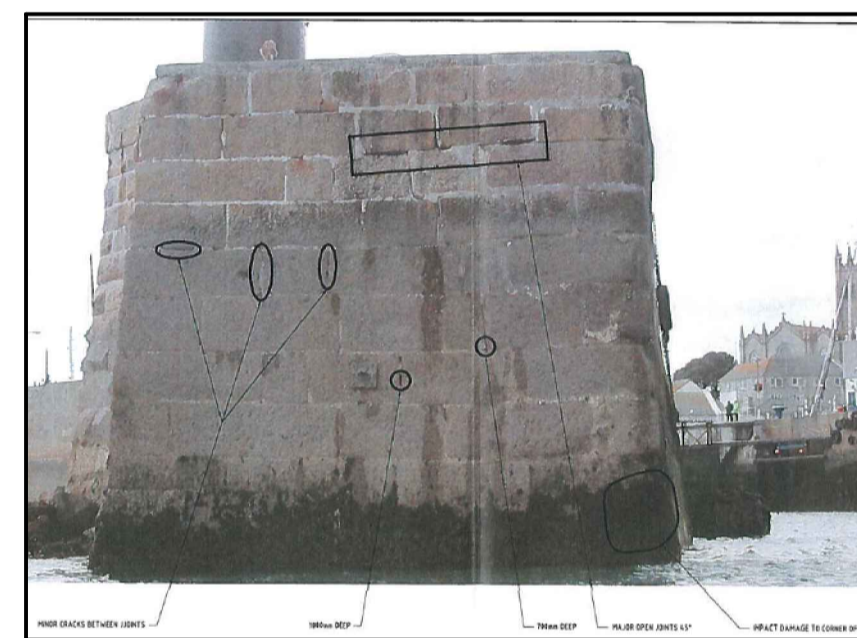
Several significant open joints have been identified towards the top of the end section of the lighthouse pier (see Photo 19 of Figure 3). Two further deep voids with depths of approximately 700mm and 1000mm are also highlighted. It is possible that these crack and voids were a product of the general subsidence of this section. However, from the 2013 inspection it appears that they have been filled in.

Photo 19 - End Section of Lighthouse Pier  
2004 - Hyder Report (Chainage N/A)

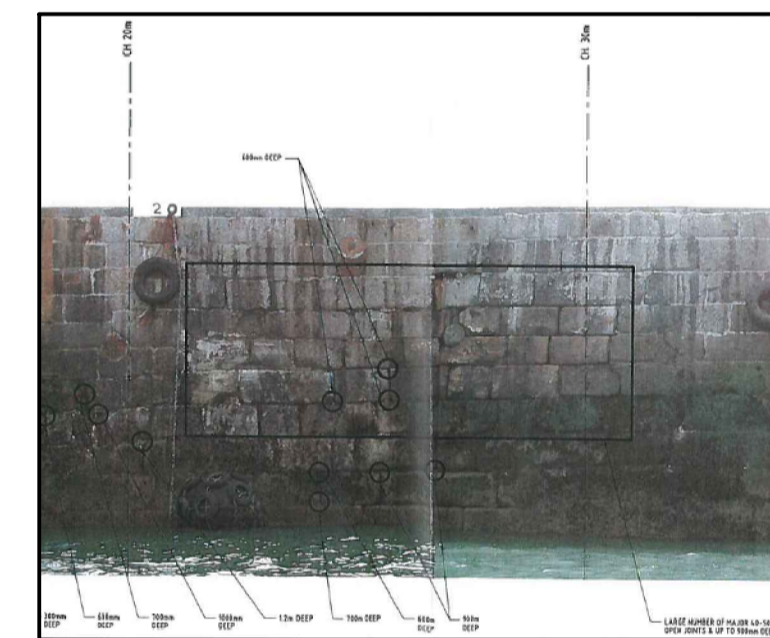
Some movement and missing pointing was identified on the inner face of the Lighthouse Pier (see photo 20 from Figure 3). This area does not appear to have changed since 2004 and while areas of the wall require repointing, there is no immediate action required.

Photo 20 - Northern Face of the Light House Pier  
2004 Hyder Report (Chainage 20m - 35m)

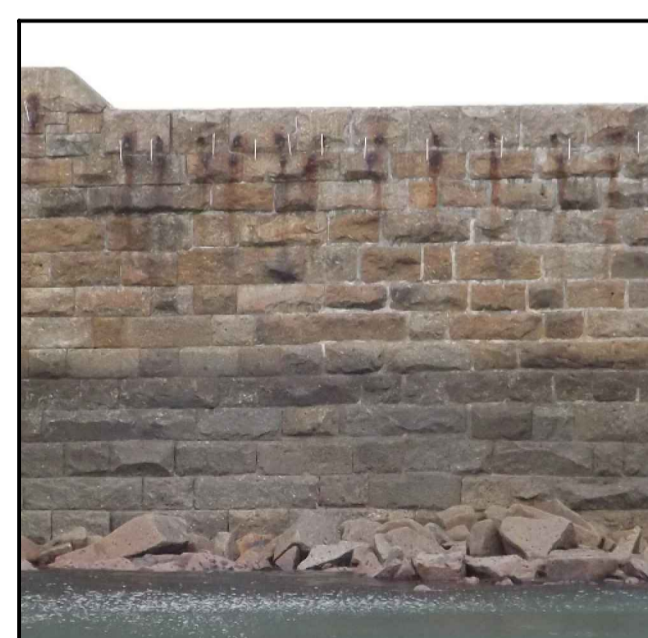
Historically, the masonry in this area has been stitched together. The steel stitching bars had rusted away, as identified in the 2004 report, and have now been replaced by stainless steel staples (See Photos 22 & 23). The need for stitching seems likely to have been a result of the separation of the wall from the body of the Pier, as discussed above. There does not seem to have been any substantial movement of the masonry since 2004, which does suggest that this was an historic problem. Critically, however, the wall has to be considered as being vulnerable to wave action and movement.

Photo 22 - Eastern Section of the Lighthouse Pier (Southern Face)  
2013 RHDHV Inspection

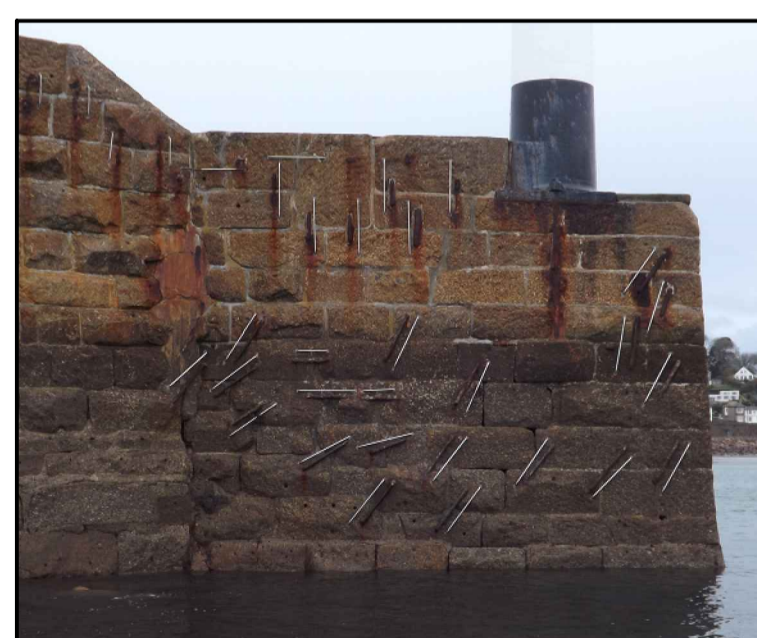
Photo 23 Western Section of the Lighthouse Pier (Southern Face)  
2013 RHDHV Inspection

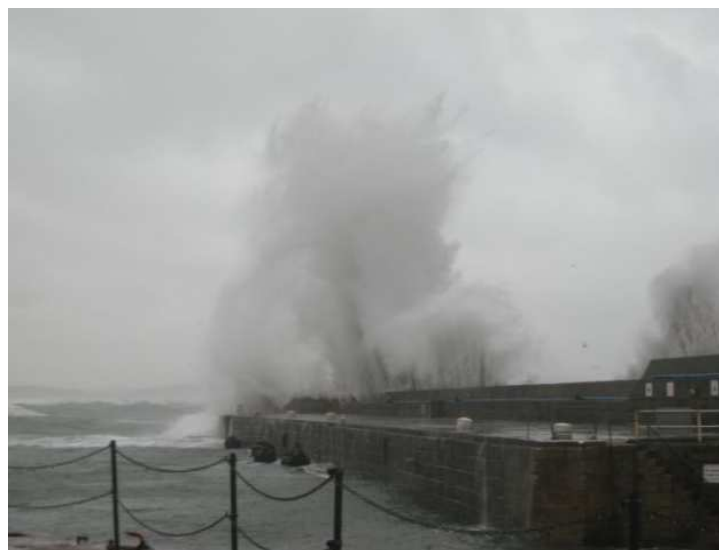
A number of factors lead to the end of the Lighthouse pier being one of the worst affected locations. The Pier itself is situated in deep water at the point most exposed to a southeast wave conditions. The pier also changes width in the vicinity of the lighthouse creating a V-shape at which wave energy can focus and leading to explosive overtopping. It is not considered likely that the overtopping and wave slam is directly responsible for the movement that has been observed in the end of the Pier. However, given the potential for separation between the seaward masonry face and the body of the pier behind, the end of the Pier is vulnerable to this high degree of wave overtopping. Wave overtopping at this location is illustrated in Photo 2.

Photo 2 – Wave Overtopping at the Lighthouse Pier  
(Courtesy Dave Simpson, Cornwall Council)

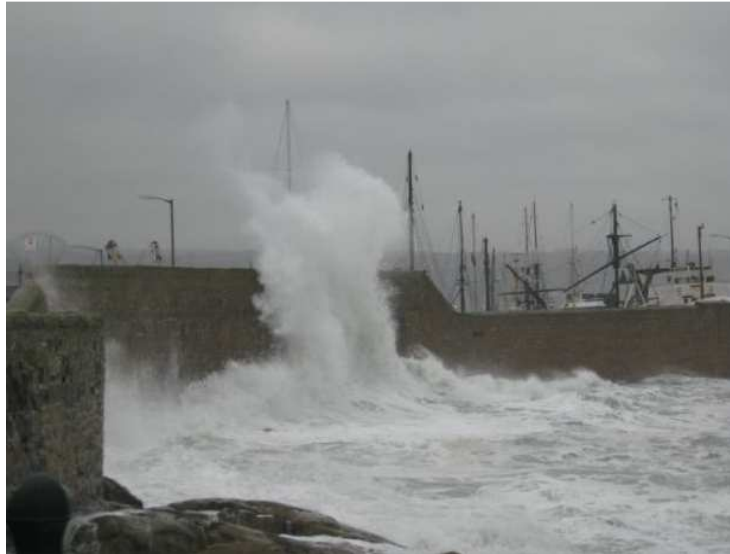
The overtopping at the rock armour occurs where the crest level has been raised. This is seen as a result of waves running up the beach and being focused by the curve of the wall at the back of the beach. Wave overtopping at this location is illustrated in Photo 3.

It is understood that during storm conditions overtopping spills onto Battery Road behind the sea wall. During a storm in January 2010 the closure of a section of Battery Road was required. It is therefore considered that the existing protection at the sea wall is not sufficient in this location.

Photo 3 - Wave Overtopping at the Rock Armour in front of South Pier  
(Courtesy Dave Simpson, Cornwall Council)
